# Ohio UAS Center

UAS Brief

WV Workshop

April 7th, 2022

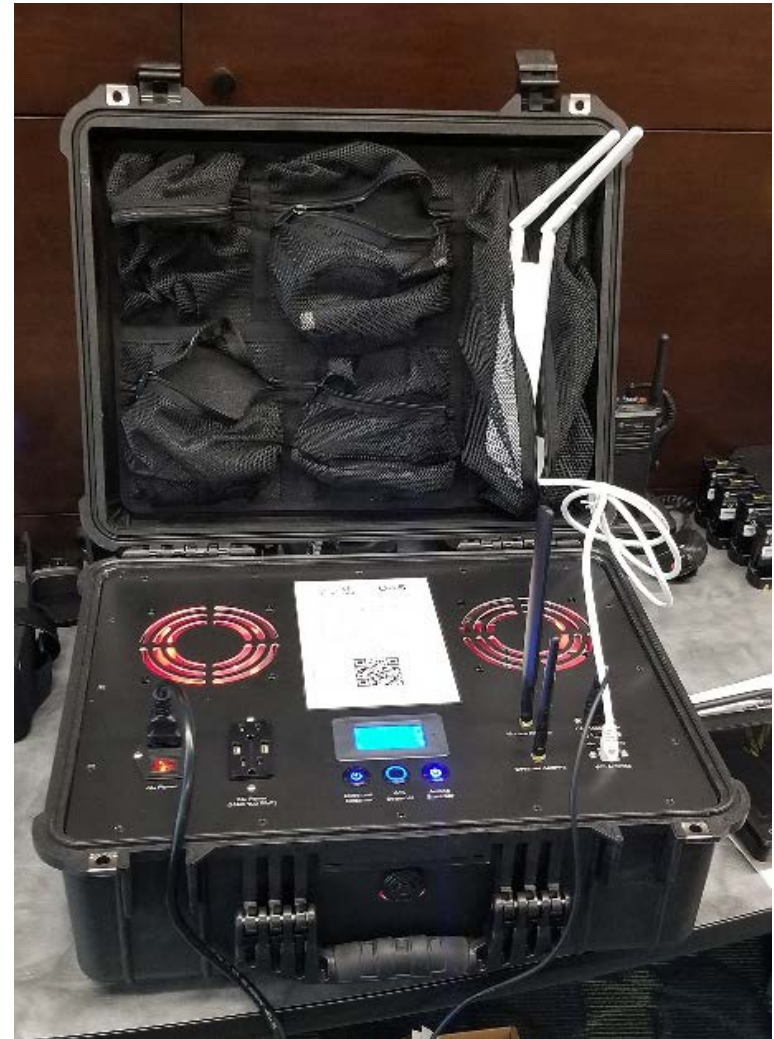
- Share data with local and remote users in real-time
- Stream Video to the ODOT Video Servers (Milestone)
- Watch Drone Video on your phone/Laptop
- Watch Video Drone feed on Goggles

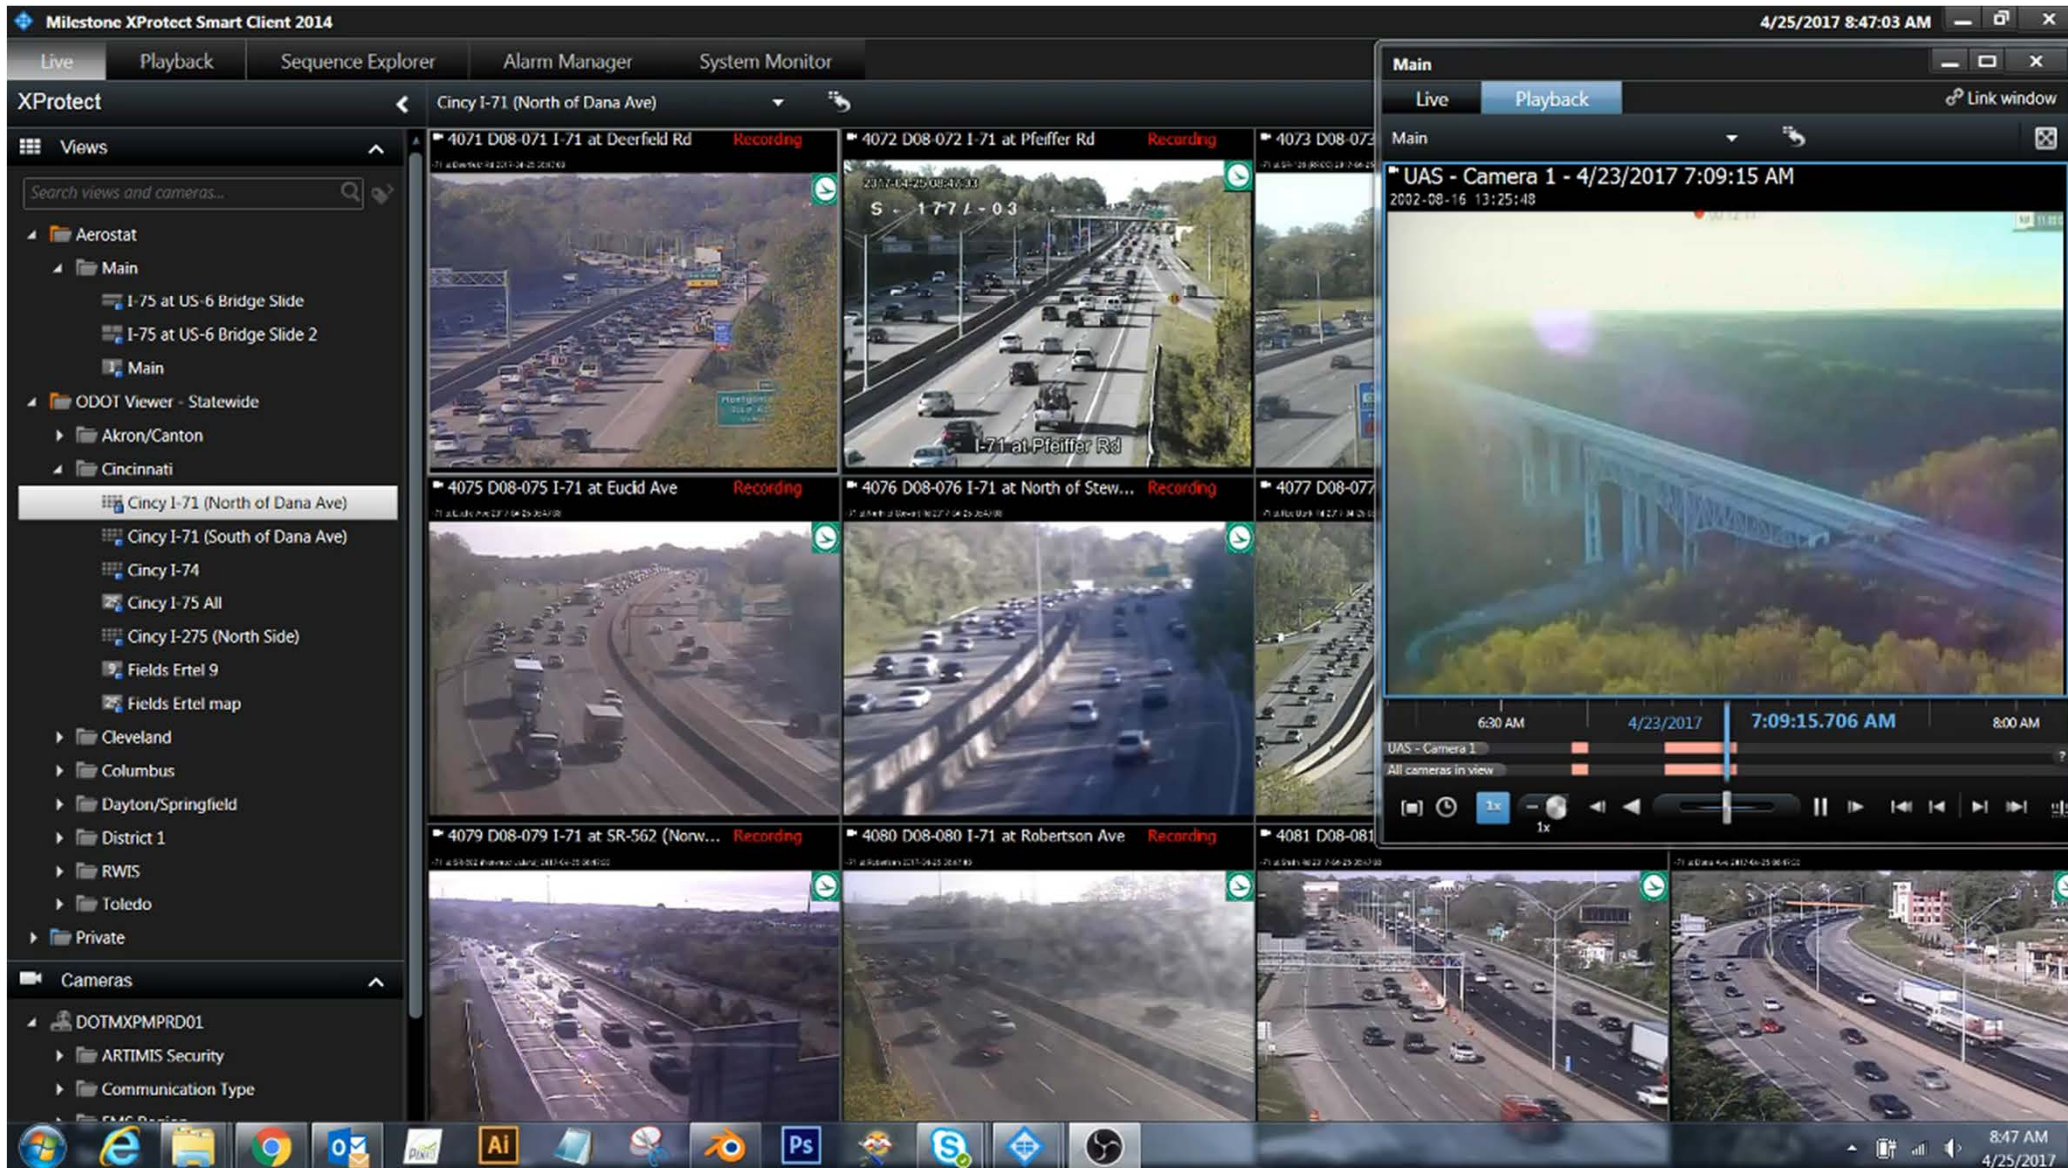
The screenshot displays the Milestone XProtect Smart Client 2014 interface. The main window shows a grid of camera feeds for 'Cincy I-71 (North of Dana Ave)'. The feeds are labeled with camera IDs and locations, such as '4071 D08-071 I-71 at Deerfield Rd', '4072 D08-072 I-71 at Pfeiffer Rd', '4075 D08-075 I-71 at Euclid Ave', and '4080 D08-080 I-71 at Robertson Ave'. Each feed shows a live view of traffic on a multi-lane highway. A 'Recording' status is visible for several feeds.

On the right side, a 'Main' window is open, showing a playback view of 'UAS - Camera 1 - 4/23/2017 7:09:15 AM'. The playback window includes a timeline with a playhead at 7:09:15.06 AM on 4/23/2017. The video shows a view of a bridge over a river.

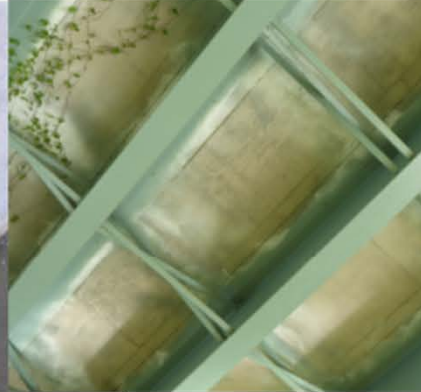
Footing  
Detail

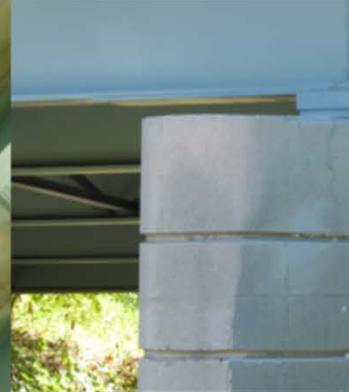
Cracking

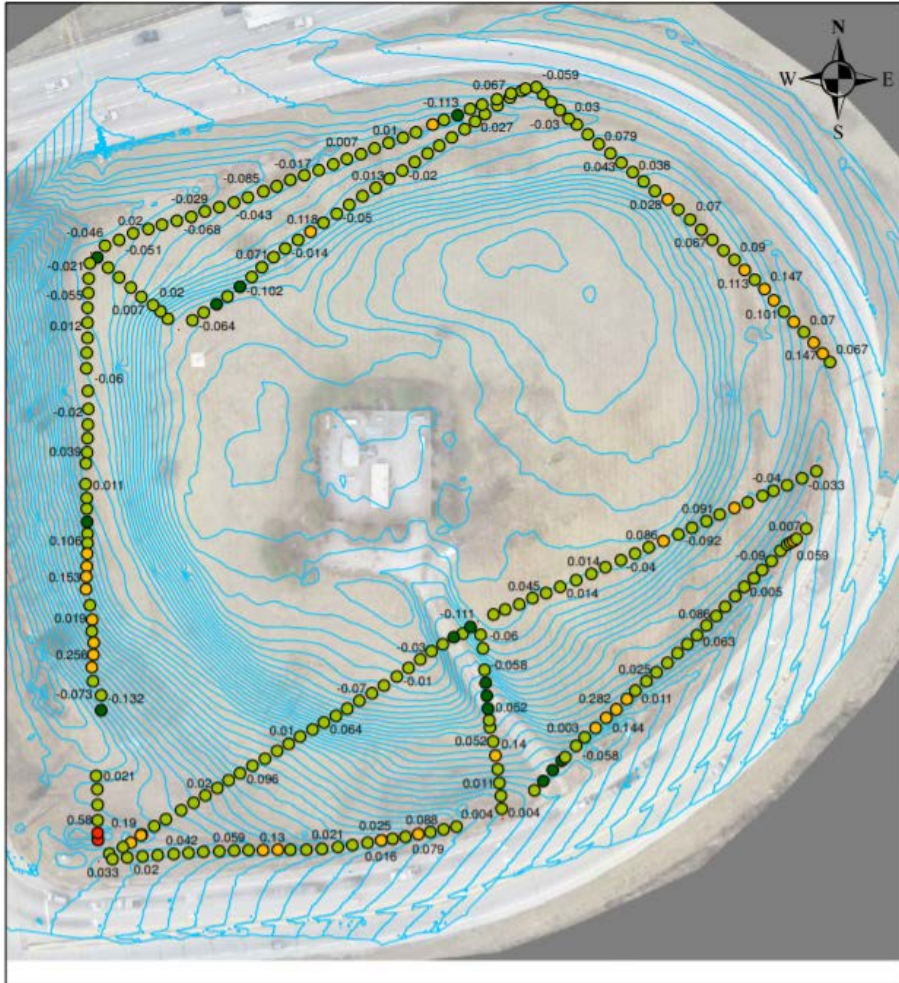
## FAI-170 AT SR256 EB OFF RAMP

Equipment: DJI Phantom 4 RTK, Trimble R6-2 TSC3, Trimble S6 Robotic total station, Topcon Digital Level  
 Procedure: ODOT S&M spec, compliant Control Point observation Topographic observation with S6 total station  
 Point cloud and orthomosaic processing by Pix4dMapper - GCPs incorporated.  
 Point cloud manual processing and datum adjustment (similar to all District scans)  
 Terrascan, Dz report similar to S&M spec control report.

Result: Class B maintained vegetated surfaces within compliance inside study area.

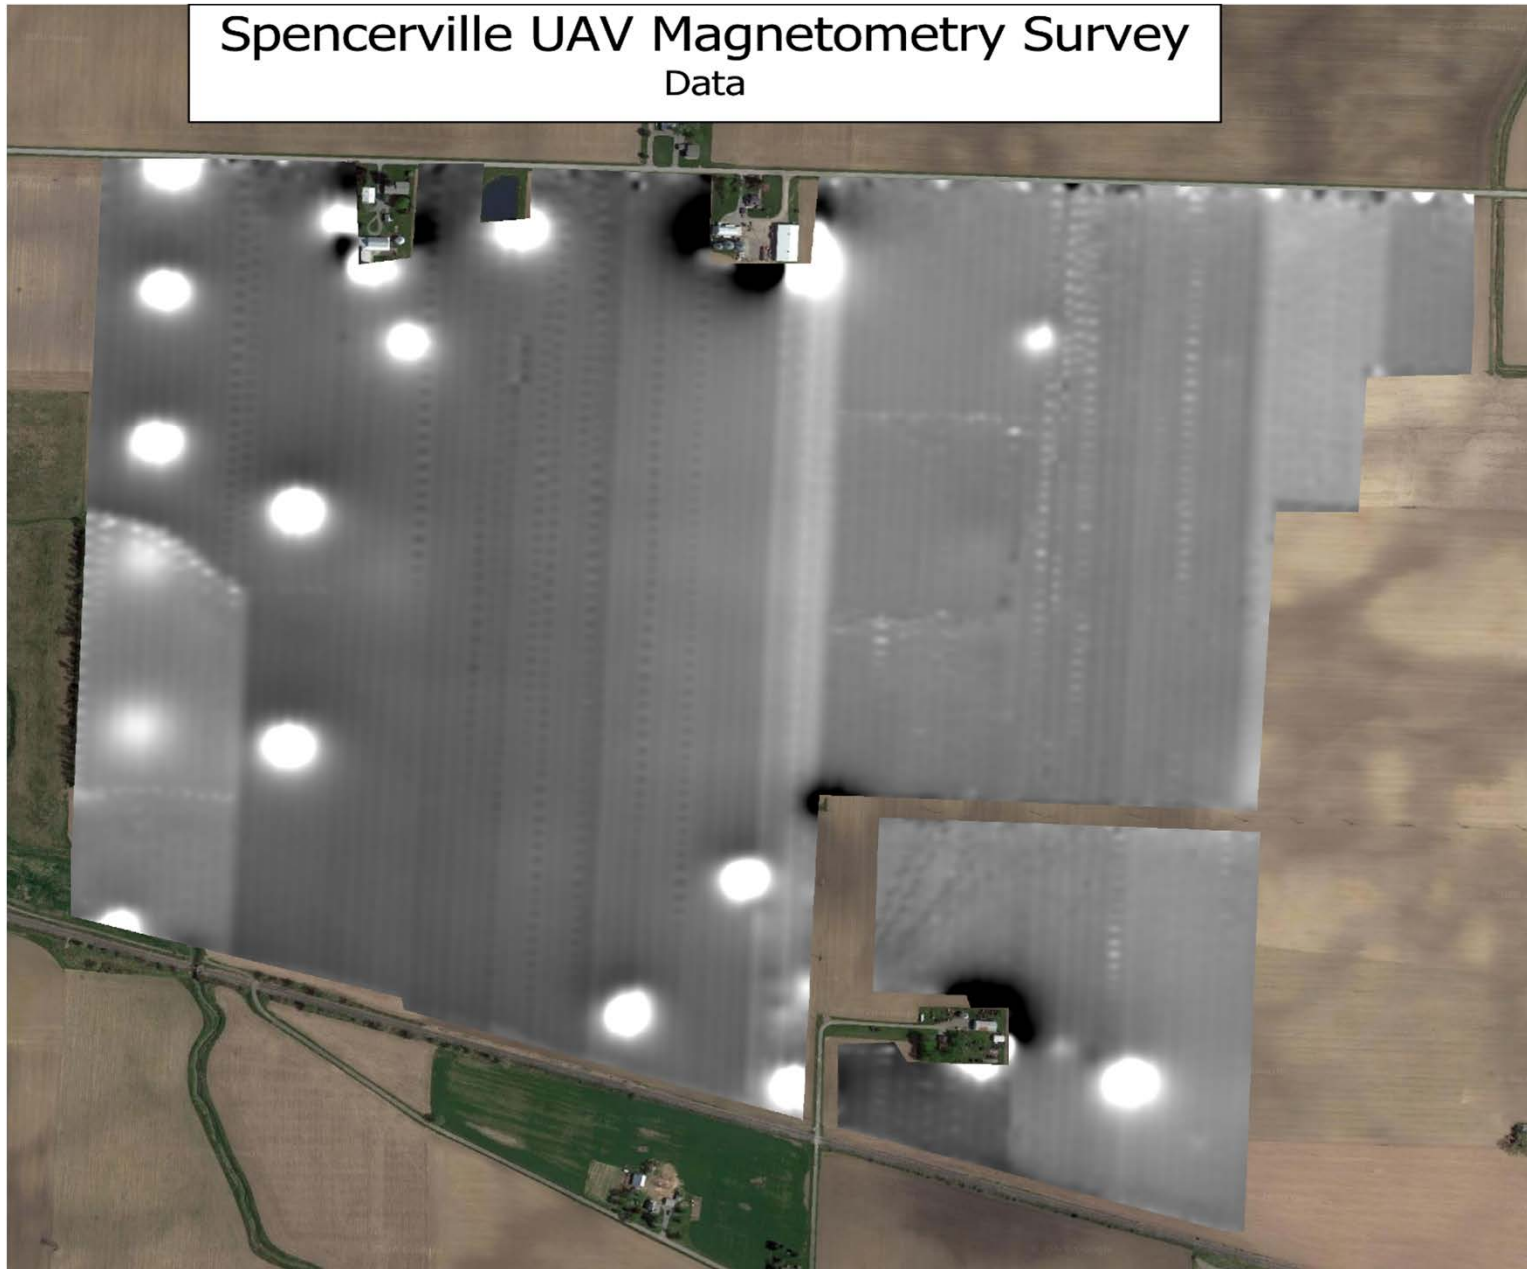
Spencerville UAV Magnetometry Survey  
Data

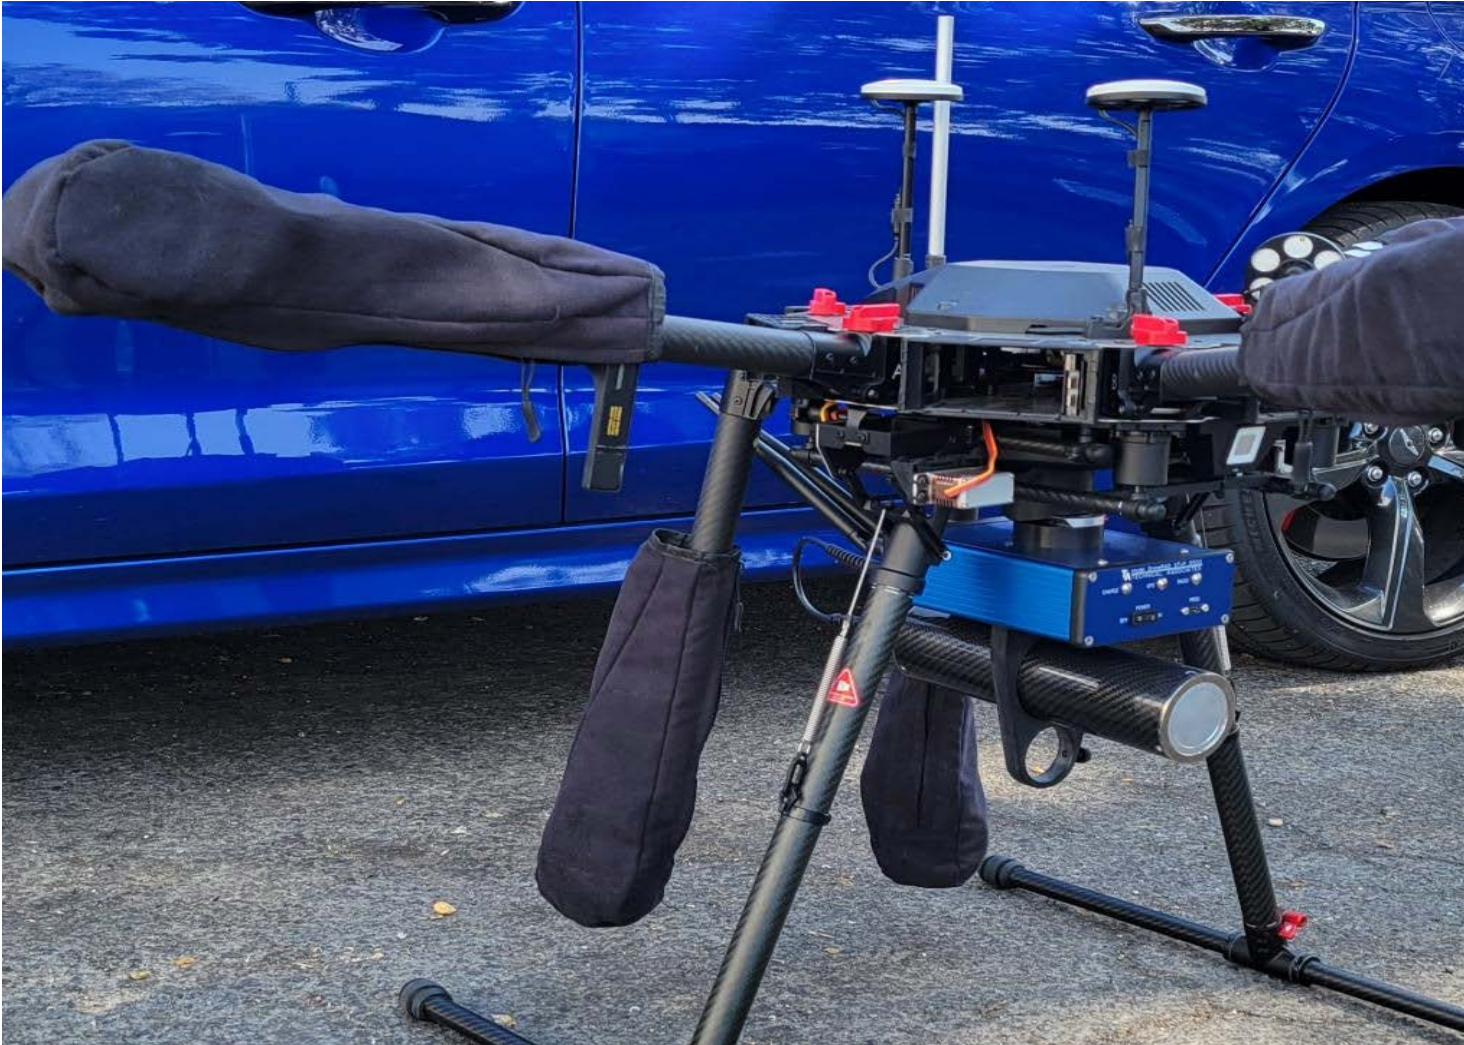
Electronics payload re-designed to accommodate measurements from three detectors.

The Search Tube (ST), NaI 2x2 detector, is the tube pictured.

The small vacant mount is for the low and high range GM tubes
